### RESEARCH MEMORANDUM

BEHAVIOR OF FORGED S-816 TURBINE BLADES IN STEADY-STATE OPERATION OF J33-9 TURBOJET ENGINE WITH STRESS-RUPTURE

AND METALLOGRAPHIC EVALUATIONS

By F. B. Garrett, C. A. Gyorgak, and J. W. Weeton

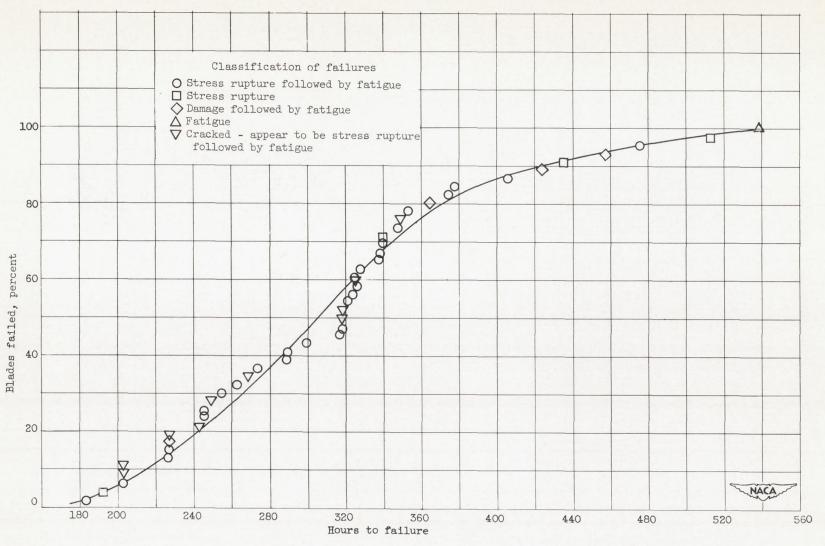
Blade failures are plotted on the cumulative-frequency curve shown in figure 2. The first failure occurred in 181 hours, and the last failure in 539 hours. a range of 358 hours.

Figure 2. - Performance of forged S-816 blades in steady-state engine operation as shown by cumulative-frequency curve.

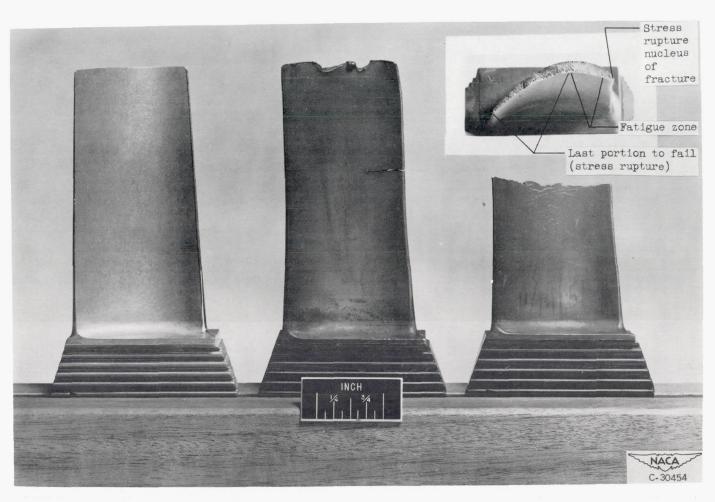
Photographs of an as-received blade and typical failed blades are shown in figure 3. The fractured blade which failed by stress rupture followed by fatigue is labeled to show the nucleus of the failure, the fatigue zone, and the last portion to fail. Stress-rupture cracks are present in the last portion to fail. The origins of failures are shown in figure 4. Of the 23 blades selected for macroexamination, 65 percent of the failures originated at the trailing edge, 35 percent at the leading edge, and 74 percent of the failure origins occurred in a zone between 2 to  $2\frac{3}{9}$  inches from the blade roots. The average distance from

Figure 3. - As-received blade and typical failed blades.

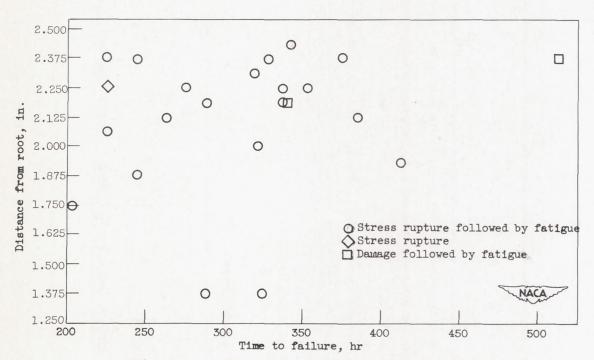
(b) Origin of fracture edges relative to blade roots.

Figure 4. - Failure origins in blades.

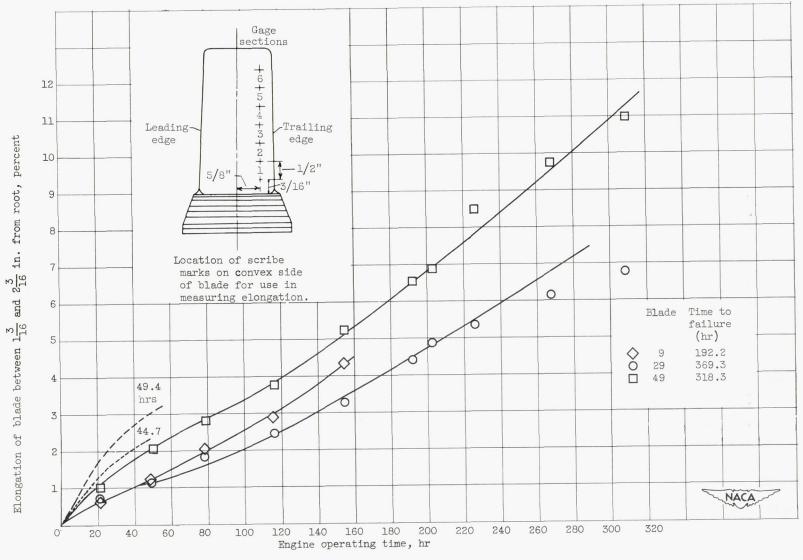
The solid curves of figure 5 show the elongation of three blades in the portion of the airfoil between  $1\frac{3}{16}$  to  $2\frac{3}{16}$  inches from the root; the dashed curves are similar data taken from reference 1. The blades of reference 1 were run in cyclic tests and failed in 44.7 and 49.4 hours. It is readily seen that the creep rates of the blades being investigated are lower than those of the previously investigated blades.

Figure 5. - Elongation of portions of blades during engine operation (gage sections 3 and 4). Dashed curves represent forged S-816 blades from reference 1. (Points shown on curves represent inspection periods.)

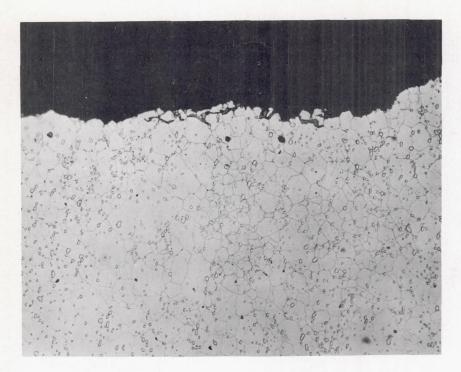
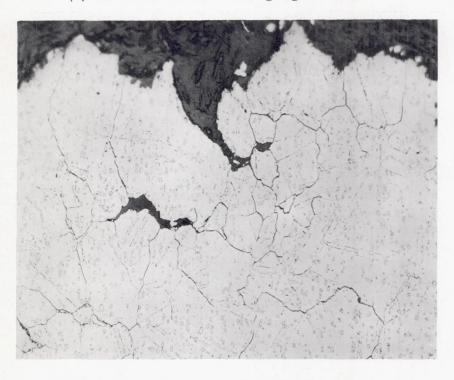
Grain size. - The specimens examined metallographically are listed in table I along with grain-size measurements. The blade that failed in the shortest time (181.2 hr) had a variable grain size near the fracture edge (fig. 6). The grain size in the immediate vicinity of the fracture was coarse near the center of the blade (A.S.T.M. 1-4-7) and fine at the trailing edge (A.S.T.M. 6-7-8). The blade that failed in the second shortest time (192 hr) had only slight differences in grain size while the remaining blades including those that failed in the longest periods were fine grained and relatively uniform in grain size.

(a) Microstructure near trailing edge of blade.

(b) Microstructure of area in center of blade.

Figure 6. - Microstructural differences in blades that failed in shortest time. (Failure time, 181.2 hr.) Etchant, 10 percent HCl; electrolytic; X250.

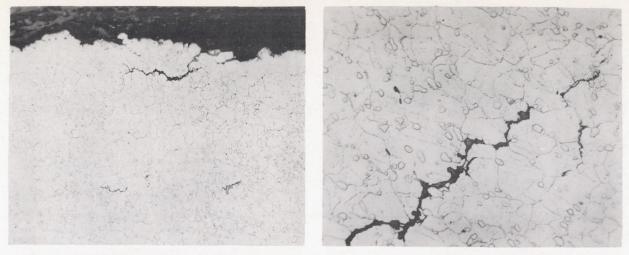
Metallographic examinations of fracture edges of the specimens that failed in 181, 254, and 317 hours confirmed that fatigue cracking took place over a portion of the fracture edges. The blades failed by stress rupture followed by fatigue. Fatigue was indicated by transcrystalline portions of the fracture edges.

Fracture edge near trailing edge of blade 4. Failure time, 316.7 hours.

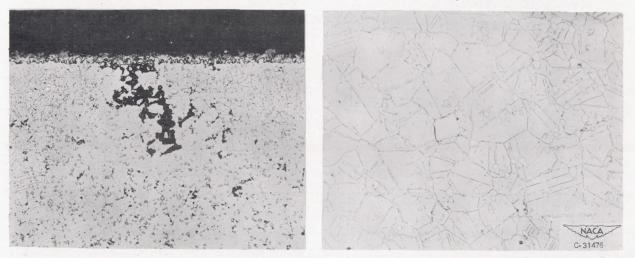
Crack near trailing edge of blade 5. Failure time, 434.2 hours.

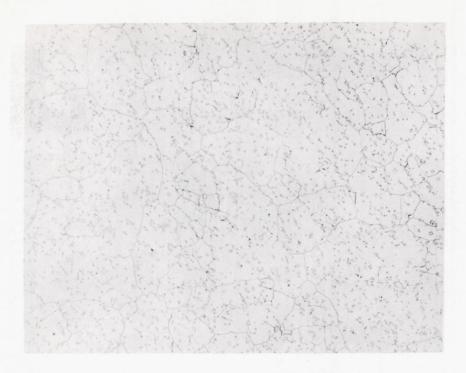
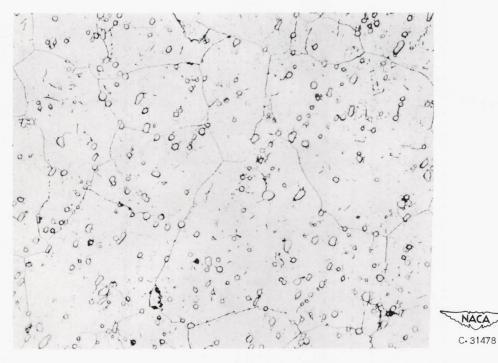
The microstructure of the blade previously run in steady-state operation (failure at 78.9 hr) was different in several respects from the structures of the blades being investigated (fig. 9). For example, except for one blade (the blade that failed in 181 hr) the grain size was more heterogeneous in the older alloy (investigated in ref. 1). In the older alloy the carbides were distributed in finer, more numerous dispersions; both salt and pepper carbides and massive carbides were more thickly distributed within the grains. The oxide penetrations in these blades seemed to be much deeper and more extensive than those found in the blades used in the present investigation. Figures 10(a) and 10(b) show, respectively, a very severe crack at the trailing edge and extensive oxide penetrations (possibly but probably not associated with cracks).

(a) General structure near leading edge showing heterogeniety in grain size and large number of carbides per unit of area. X250.

(b) General structure near trailing edge showing salt and pepper precipitates, probably carbides. X750.

Figure 9. - Microstructure of older forged S-816 blades for comparison with structures of blades used in present investigation. Etchant, 5 percent aqua regia in water followed by 10 percent hydrochloric acid in ethyl alcohol; both electrolytic.

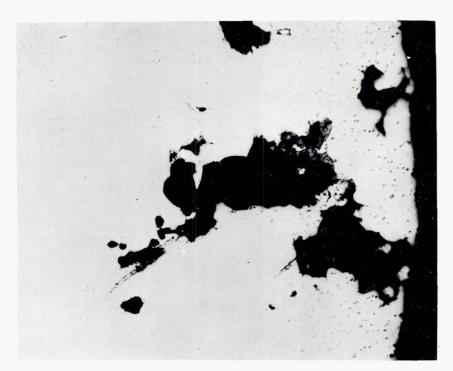
(a) Stress-rupture crack below actual fracture-edge: cross section of airfoil.

Figure 10. - Edges of older blade run in steady-state operation for 78.9 hours before failure. Structures shown for comparative purposes.) Etchant, none. X250.

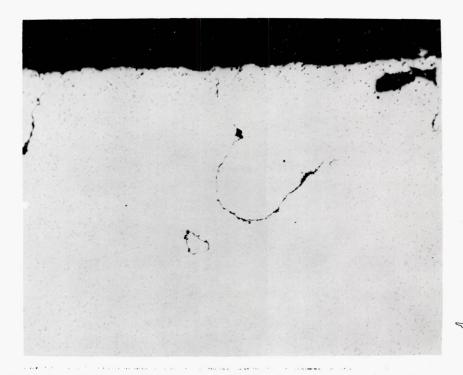
(b) Probable oxide penetration near trailing edge on concave edge of airfoil.

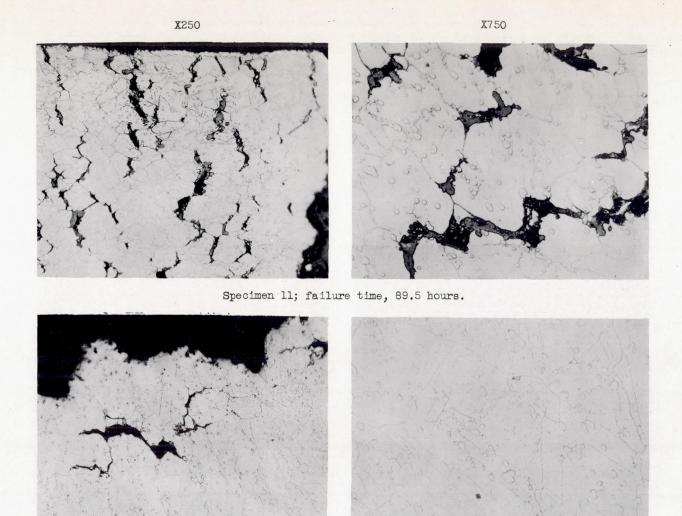
Specimen 9; failure time, 218.8 hours.

The photomicrographs of figure 11 were taken at or near the failure zones of the rupture bars. Cracks, intergranular tears, and fracture edges are evident.

Figure 11. - Microstructures of fractured stress-rupture specimens showing intergranular tears and changes with time at temperature of 1500° F and stress of 20,000 pounds per square inch. Etchant, 5 percent aqua regia in water followed by 10 percent hydrochloric acid in ethyl alcohol; both electrolytic.

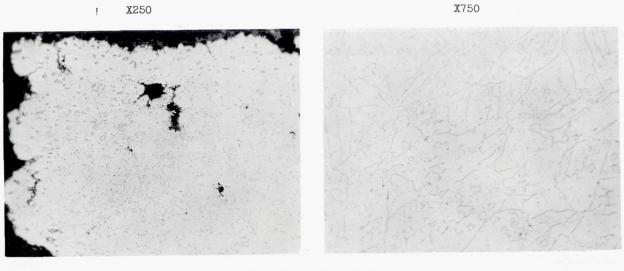
Specimen 6; failure time, 618.0

Figure 11. - Concluded. Microstructures of fractured stress-rupture specimens showing intergranular tears and changes with time at temperature of 1500° F and stress of 20,000 pounds per square inch. Etchant, 5 percent aqua regia in water followed by 10 percent hydrochloric acid in ethyl alcohol; both electrolytic.

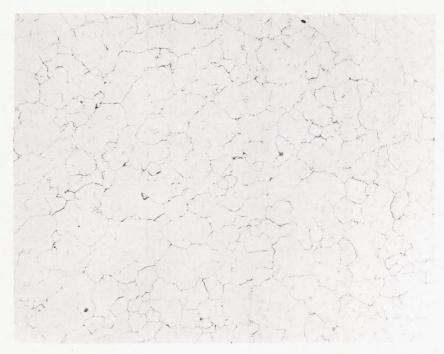
Grain size of fractured bars. - The grain size of the bar that did not fail after 1346 hours in the stress-rupture test was somewhat smaller than that of the other specimens (A.S.T.M. 6-7-8 against A.S.T.M. 4-6-8). Similar differences in grain sizes were found in the remnants of the blade airfoils from which the stress-rupture bars were cut (fig. 12).

(a) Microstructure of untested segment of blade from which stress-rupture specimen that fractured in 89.5 hours was obtained.

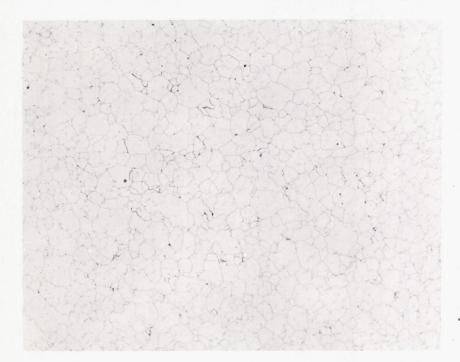
(b) Microstructure of untested segment of blade from which stress-rupture specimen that did not fracture after 1346 hours was obtained.
